WASTE SITE RECLASSIFICATION FORM

Waste Site Code(s)/Subsite Code(s): 300-290, Radiological Debris Area East of Horn Rapids Disposal Landfill

**SUPPORTING INFORMATION FOR RECLASSIFICATION OF THE
300-290, RADIOLOGICAL DEBRIS AREA EAST OF HORN RAPIDS
DISPOSAL LANDFILL WASTE SITE**

Attachment to Waste Site Reclassification Form 2014-113

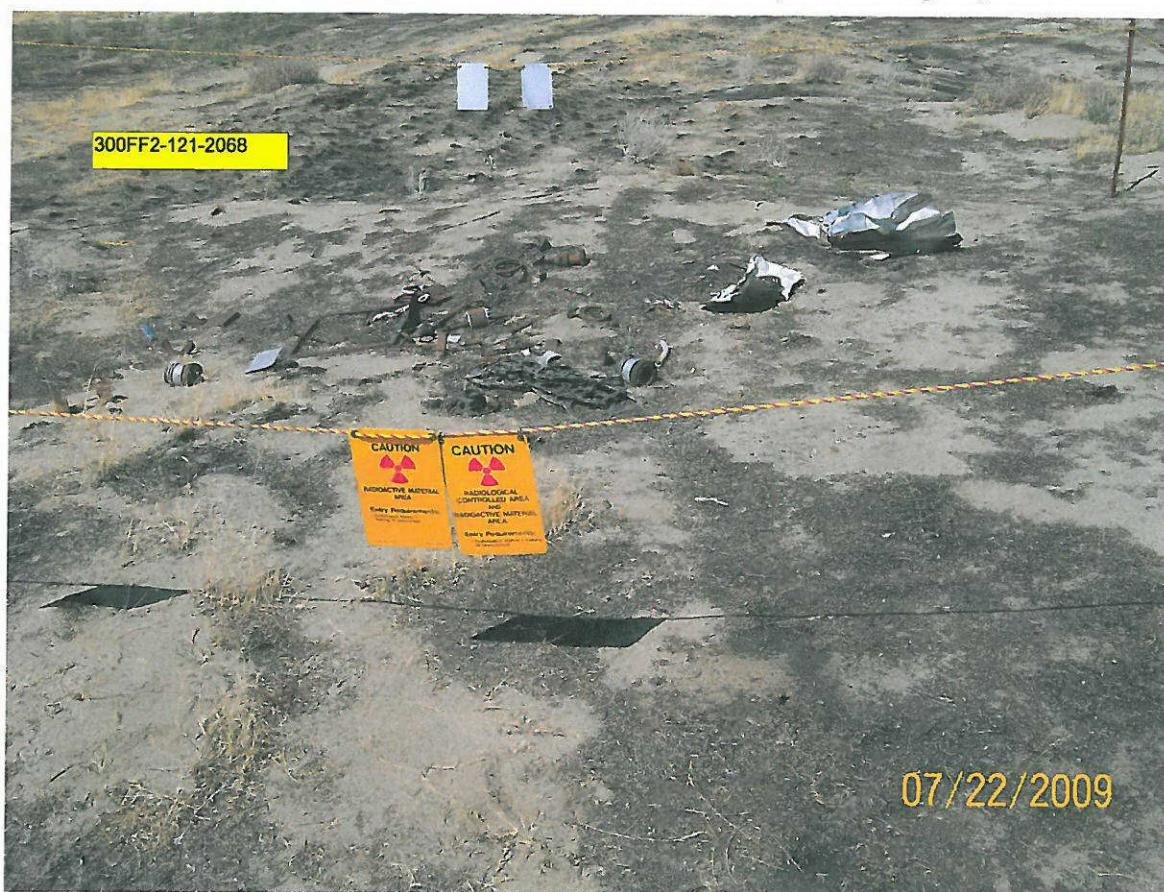
Figure 2. Photograph of the 300-290 Waste Site, Dated July 22, 2009.

A walkdown was conducted on July 22, 2009, to support an orphan sites evaluation (WCH 2009). The posted area was located. The material in the posted area consisted mostly of rusted metal automotive parts, scraps of crumpled sheetmetal, electrical wire debris, and engine gaskets. A 2009 photograph of the waste site is provided in Figure 2.

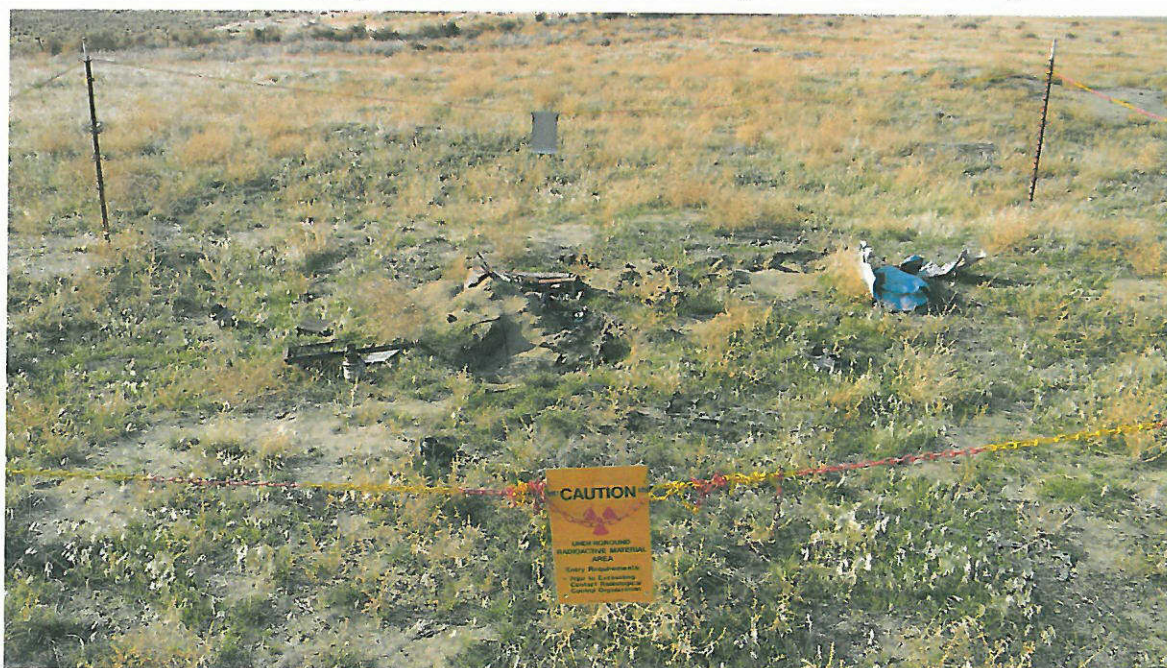
Figure 3. Photograph of the 300-290 Waste Site, Dated December 2, 2014.

An in-process composite soil sample was collected from across the waste site on September 25, 2014. Additionally, two test pits were hand excavated under the surface debris to determine if additional debris was present below the ground surface. No debris or stained soil was observed below the surface. Following sampling and test pitting activities conducted on September 25, 2014, an additional site walkdown was conducted on December 2, 2014. A photograph of the current site conditions is provided in Figure 3.

The in-process sampling results support a reclassification of the 300-290 waste site to Final No Action.

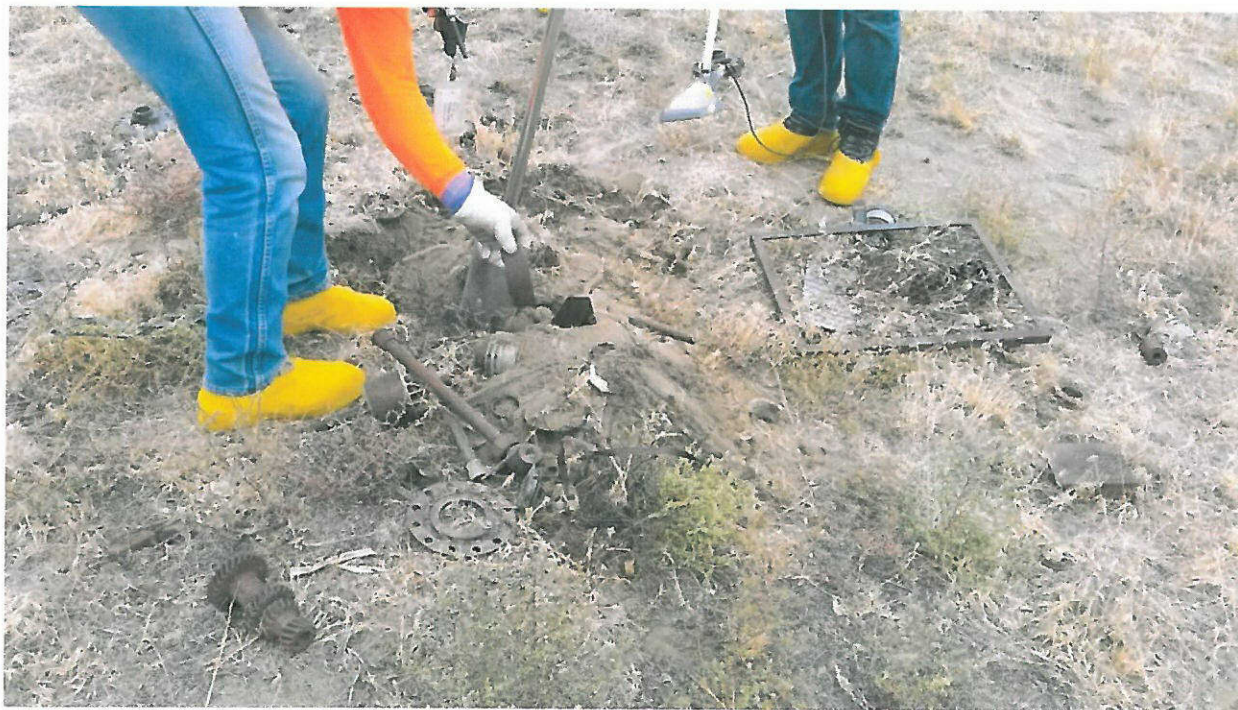
Figure 4. Photograph of Hand-Excavated Test Pit at the 300-290 Waste Site, Dated September 25, 2014.

An in-process composite sample (J1V0D8) consisting of 30 aliquots of soil from across the waste site was collected on September 25, 2014. Aliquots were collected from locations evenly distributed across the site and from soils underneath the debris, which was moved before collection. In addition, two test pits were hand excavated under concentrations of metal to approximately 0.6 m (2 ft) below grade to determine if debris was present below the surface and assess the conditions of the underlying soils (Figure 4). No debris was encountered and no soil staining was observed. Site observations concluded that the debris was limited to a small, localized, surface deposit and no materials continued at depth.
